Use of Field Data in Determining Rock Slope Stability: Case Study North – South Malaysia Highway

Abdul Rahman Huraissen Masri
Politeknik Sultan Abdul Halim Mu'adzam Shah
arhm_amn@yahoo.com

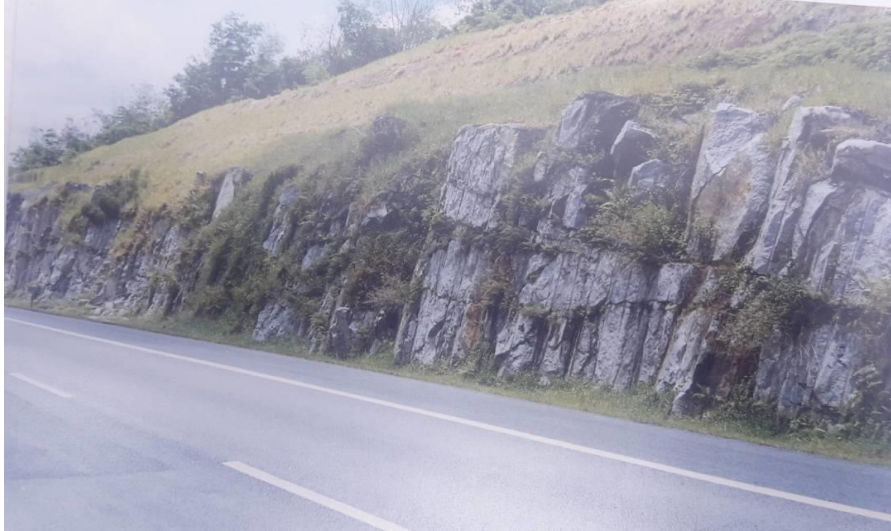
Picture 1: Showing a section of the study location Slope A : KM 173.7 – in the North direction

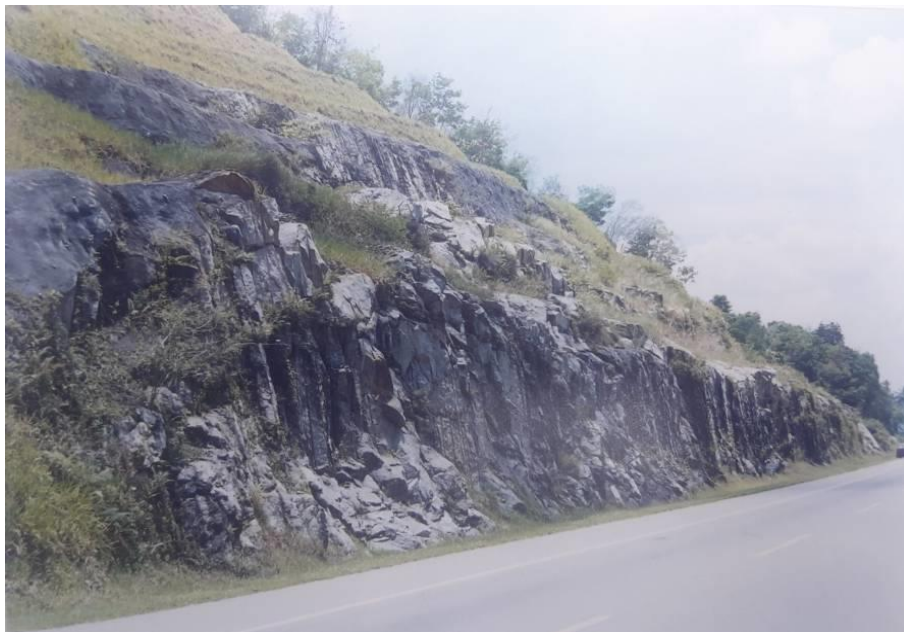
Picture 2: Showing a section of the study location Slope B: KM 173.7 – in the South direction

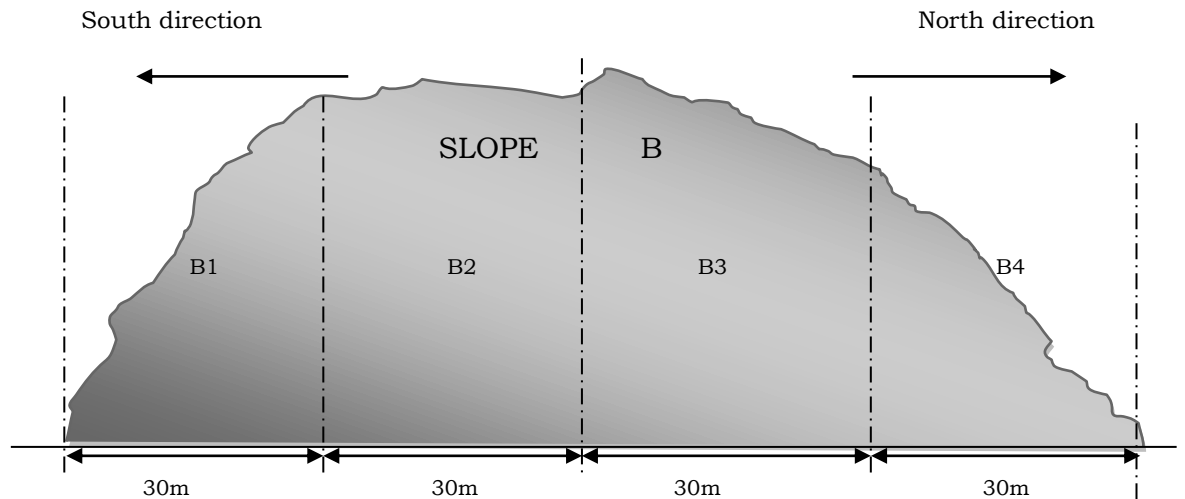
For the area under study the angle of dip for the slope face and its direction of dip is taken over a distance of 120 meters. The slope is divided for every 30 meters into 4 segments and named accordingly as Slope B-1 (for first 30 meters), Slope B-2 (for the 2nd 30 meters), Slope B-3 (for the 3rd 30 meters) and Slope B-4 (for the 4th 30 meters). Figure 2 illustrates the division of the slope. A number of readings are taken and the values of the angle of dip and the direction of dip for the slope face for every segment and this is shown in Figure 1.

Figure 2: Segmentation of Slope B. Data collection and geological observation is made for every 30 m

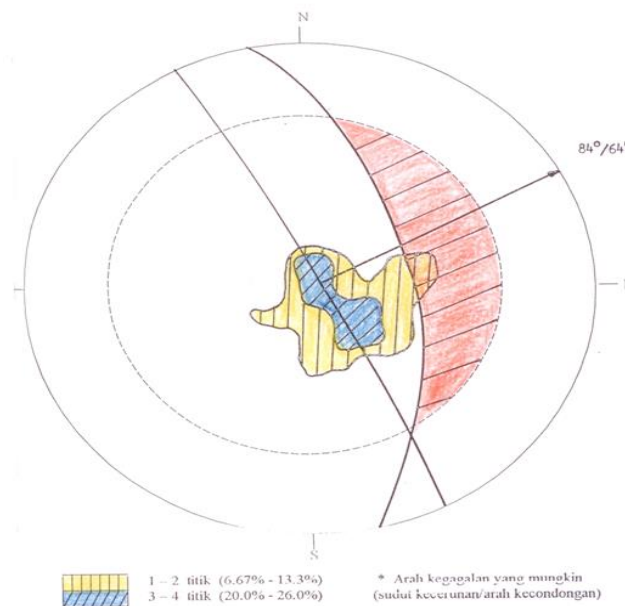
Based on the plotting of the angle of dip and the direction of dip coupled with the contour from combination of points of these two parameters and the drawing of the circle on the stereographic net and the friction angle, θ , plotting (Figure 3), therefore the result of the analysis of the rock slope stability is tabulated in Table 2. This table also shows the types of probable failure.

Figure 3: Plotting of the analysis of slope stability: Slope B (30 m No.2)

Based on the Bienawski classification system, it was found that the classification for both rock slopes were in Class 1 (very stable and safe), while using the Laubscher system provided a result in Class 2 (good). The contouring and plotting demonstrate that the slope is in a stable condition and the type of failure if it happens is the wedge type. The contouring results from the dip angles and the direction of dip for every 30 meter slope block show that the high intensity distribution contour for both rock slopes are out of the area of the danger of failure (*Red Zone*). The high intensity contouring shows that the rock slope is in a stable and safe condition.

Granite rock at the location of study shows three sets of fractures criss-crossing one another. This fracture exists in the discontinuity set which have a similar orientation. These three sets of fractures has very similar orientation in the direction of North-west – South-west, North – South and North - East.

Based on these two results, it is possible to suggest that both the two rock slopes under study are stable and safe and would not require any method of strengthening for the present time. However their condition in the future may change depending on the effects of a number of factors such as ground water, weathering and earth movements (earthquakes).
