Quarry Dust: The Potential of By-Product Waste as Sulfate Attack Resistance in Cement Composites

Abstract

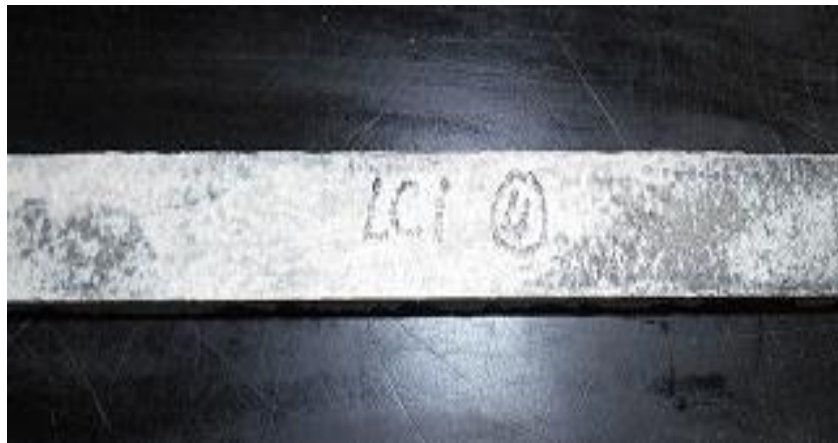
According to Figure 1, the samples without the addition of quarry dust (0 wt.%) showed the appearance of salt crystallization or efflorescence on the

surface of the cement composites. This situation happened when there has no addition of quarry dust in the samples, which tends to block the gap between the mixture particles and reduce the path for soluble salts to migrate through the surface of the cement composites. The justification was parallel with the statement by Michael (1986), salt crystallization occurred in the combination of three conditions such as water-soluble salts, sufficient moisture in the structure to render the salt into soluble solution, and a path to migrate through the surface which can cause efflorescence. This process was described as a physical attack on cement composites and did not involve any chemical interaction between the sulfate ions and the hydration of cement composites. However, if untreated, the trapped salt can be crystallized and its expansion tends to form cracks and spall the structures or lead to masonry problems (Patrick, 2007). Besides that, the findings revealed the utilization of ordinary Portland cement that is high in tricalcium aluminate (C_3A) compound and there has no improving resistance such as used the addition of pozzolanas could not resist the sulfate attack, as stated by Murdock et al (1991). In addition to this, Eglinton (1998) and Lota (1995) stated that the principal reason for the mortar resistance concerning sulfates is due to the low quantity of calcium aluminate hydrates (C_3A).

Figure 1: Cement composites without the addition of quarry dust

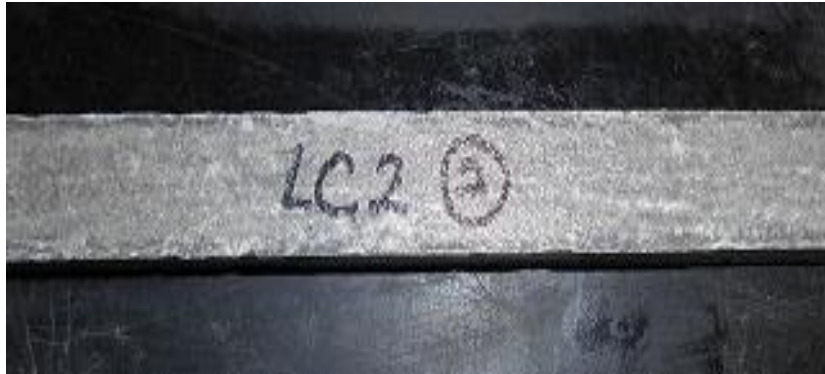
Next, Figure 2 showed the samples of cement composites with the addition of quarry dust at 12.5 wt. %. Regarding Figure 2, there have no obvious signs such as salt crystallization and major deteriorations were detected on the surface or edges of the cement composites, almost confirmed by the findings revealed by Nasser and Meriam (2013) until 90 days of immersion in a sodium sulfate solution. According to the previous result from proportioning study, the strength properties of the cement composites such as compressive and tensile strength showed the highest value amongst the rest, and at the same time lowest in water absorption and moisture content. The consumption of quarry dust in the cement composites improved the durability and strength properties due to the excellent resistance related to the silica and filling action. The fine particles of quarry dust increase the resistance of cement composites against sulfate attack by decreasing the porosity and permeability factor. The excellent resistance is related to the

filling action of fine particle size, and the pore refinement process occurring due to the conversion of portlandite into secondary C-S-H gel through a strong pozzolanic reaction (Lee et al., 2005).

Figure 2: Cement composites with the addition of 12.5 wt. % quarry dust

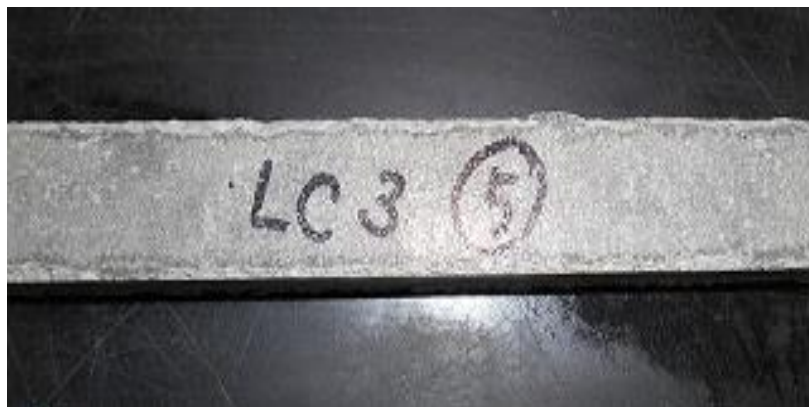
However, the samples of cement composites with 17.5 wt. % of quarry dust in Figure 3 showed obvious degradation at the edges of the cement composites but did not show any sign of efflorescence. This situation happens as the previous explanation of the pozzolanic effect with the addition of 12.5 wt.% of quarry dust in cement composites. The cement composites displayed degradation starting at the surface and corners, and progressively enters into cement composites by scaling and spalling, whereby finally reduces into friable mass (Shetty, 1986). The damages answered the findings of the lowest compressive strength obtained during the proportioning study. Furthermore, the other factors influencing the deterioration of cement composites are regarded as the high value of water absorption and moisture content in previous findings. The high percentages of quarry dust might be one of the factors that contribute to the alkali-silica reaction (ASR) in cement composites. ASR occurred when three conditions as well as reactive forms of silica in quarry dust, high alkalinity in pore solution, and sufficient moisture (Portland Cement Association, 2007) exist in cement composites. The combination of alkali-silica gel and moisture triggered the pressure and create the tendency to induce the deterioration of scaling and durability properties of the cement composites.

Figure 3: Cement composites with the addition of 17.5 wt. % quarry dust
